PHASE I INSPECTION REPORT

NATIONAL DAM INSPECTION PROGRAM

Broadford Run Dam, Little Youghio gheny River Site
Number 6. (NDI I.D. Number MD-36 Ohio River Basin)

ACKENHEIL & ASSOCIATES, BALTIMORE, MD, INC.
7902 BELAIR ROAD
BALTIMORE, MARYLAND 21236

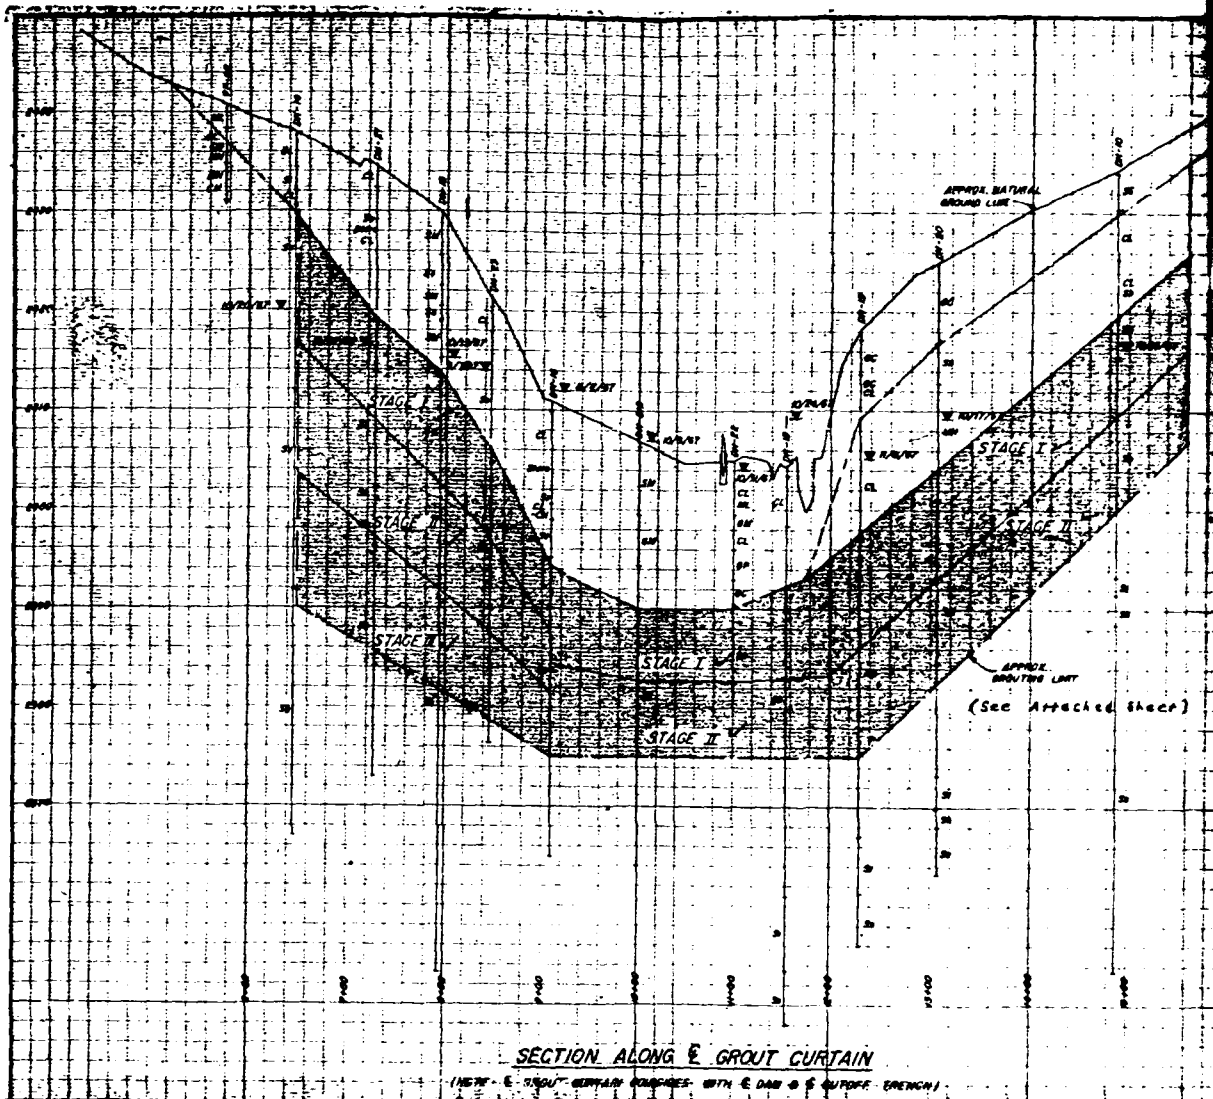
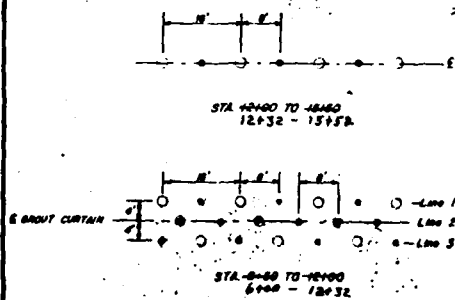
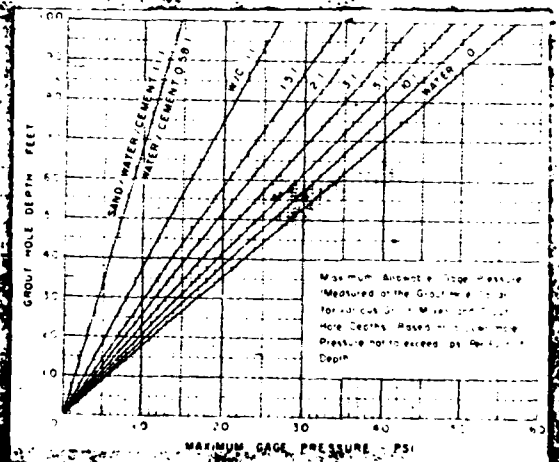
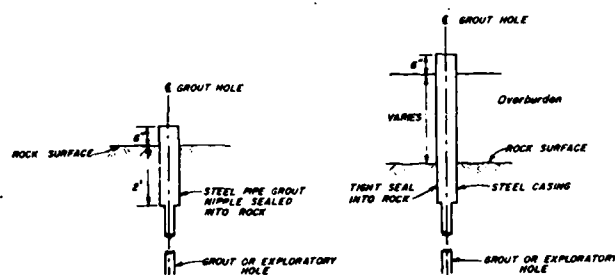
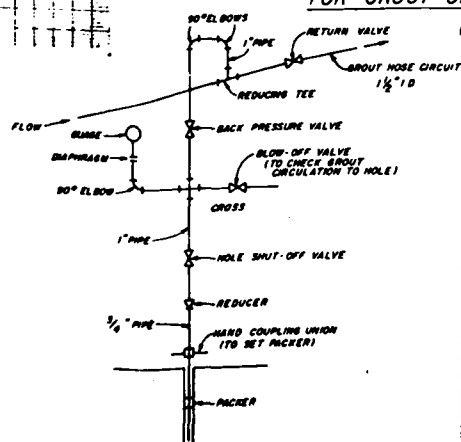
PLATE NO.5

Cement grout was injected into foundation bedrock to form a curtain for the purpose of reducing seepage flow. Foundation bedrock consists predominately of highly fractured and jointed shale and sandstone and includes a fault rubble zone. (Refer to Plate No. 5 and Regional Geology, Appendix F.)
